Re: Draft Final Report, Contract No. F33615-97-C-3215

MATHEMATICAL MODEL TO PREDICT FATIGUE CRACK INITIATION IN CORRODED LAP JOINTS

TECHNICAL REPORT

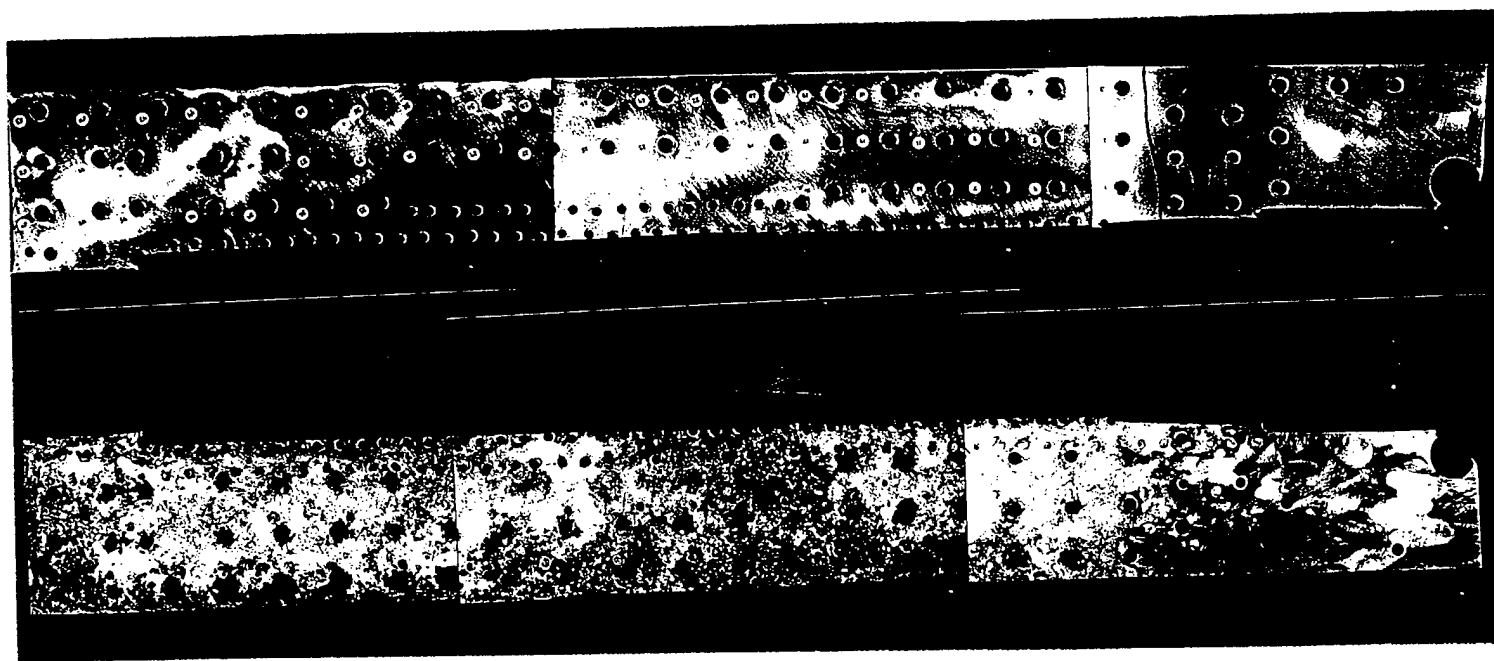
Figure 4.1.   Faying Surface Of Lap Joint Section Of KC-135. (Top) Outside Surface
(Bottom) Contact Or Faying Surface

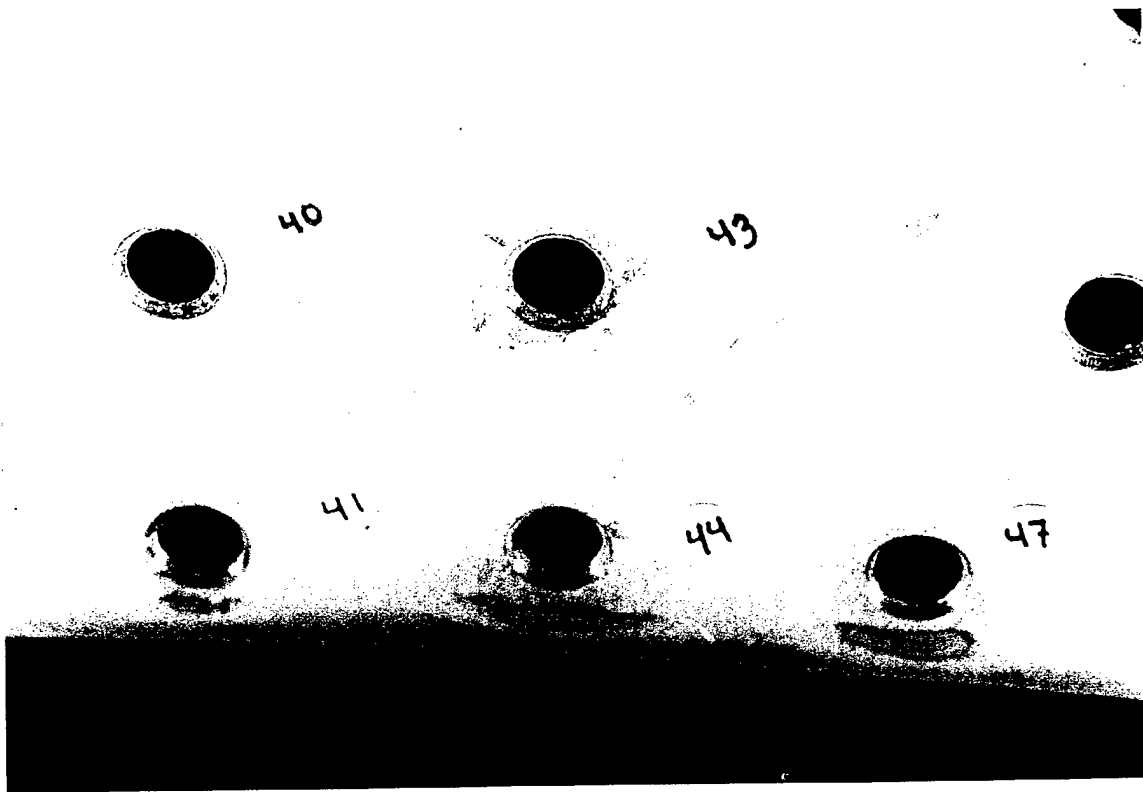
As shown in Figure 5.1, the outside of the lap joint shows little or no evidence of corrosion, but on the contact or faying surface of the lap joint, voluminous corrosion products, which are characteristic of exfoliation corrosion, can be observed.   For example, Figure 5.2 shows a section of the lap joint with copious amounts of white colored corrosion product, hydrated Al_2O_3 or $Al(OH)_3$, which is thought to be responsible for the pillowing effect and resulting stresses on the skin and fasteners.

Figure 5.1.   Outside Surface Of Lap Joint.

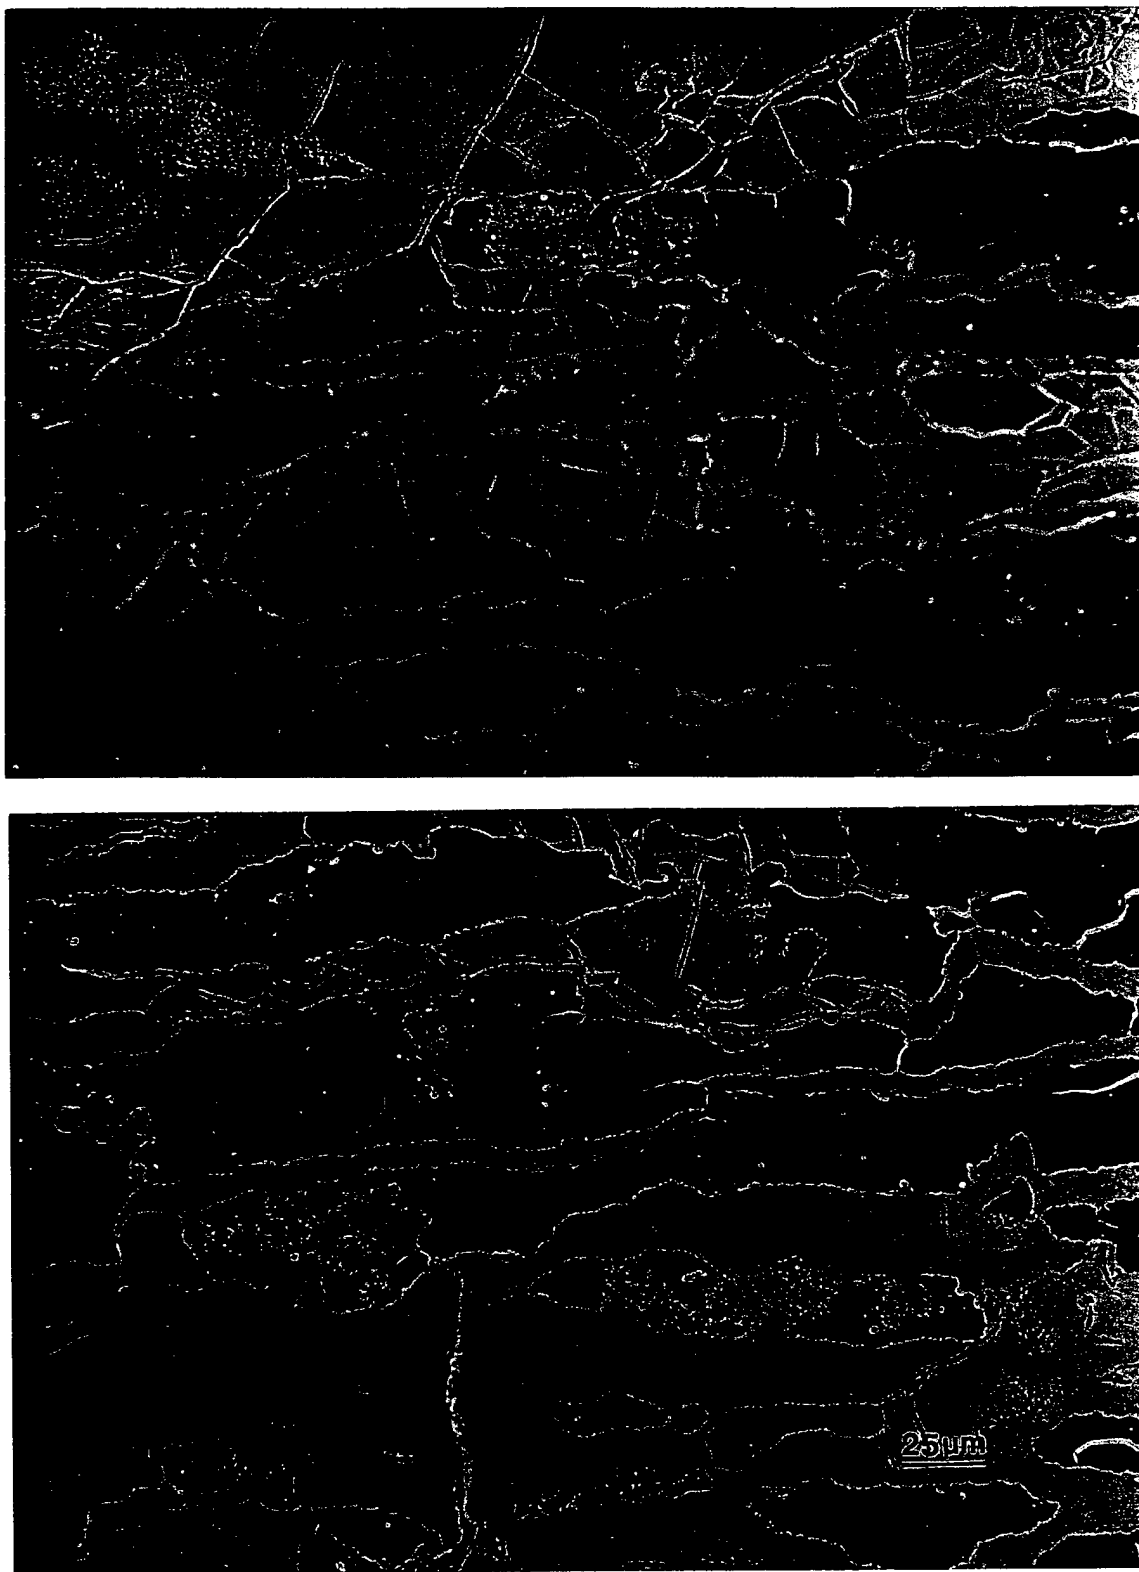
Metallographic cross sections through the lap joint section, such as shown in Figures 5.3 and 5.4, show extensive corrosion of the aluminum alloy skin, including pitting, exfoliation corrosion and intergranular corrosion.   The figures show that exfoliation corrosion can either start from the faying surface or from a fastener hole.   In the latter case, exfoliation can propagate over long distances before sufficient corrosion product is build up to create the pillowing effect. Once sufficient corrosion product has formed, lifting of the grains is observed, which is characteristic for severe exfoliation corrosion. Once the grains are lifted off, and surrounded by the hydrated aluminum hydroxide, corrosion of the alloy grains continues by an apparent form of dealloying corrosion. The optical micrographs of exfoliated grains, shown in Figure 5.5, clearly demonstrate the dissolution process of the grains.   Specifically, the micrographs show remnants of the corroded grains indicating a selective dissolution process. In order to gain further insight into this particular mode of corrosion, a metallographic cross section was examined with energy dispersive X-ray spectrography (EDS) in a scanning electron microscope (SEM). The scanning electron micrographs in Figure 5.6 show a exfoliated grains with one grain showing evidence of dealloying corrosion.   The EDS analysis of the exfoliated grain in Figure 5.7 indicates that the grain was depleted aluminum.   Some copper and manganese rich areas and particles remained as indicated by the EDS spectrographs.

Figure 5.4. Optical Micrographs Of Exfoliated Grains Showing Preferential Dissolution Of A Phase Of The Aluminum Alloy.

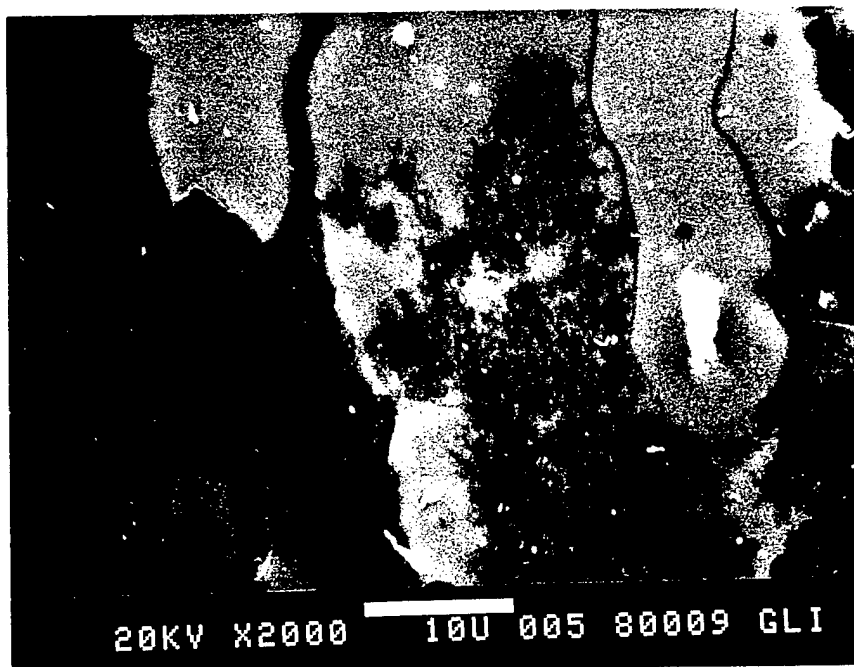
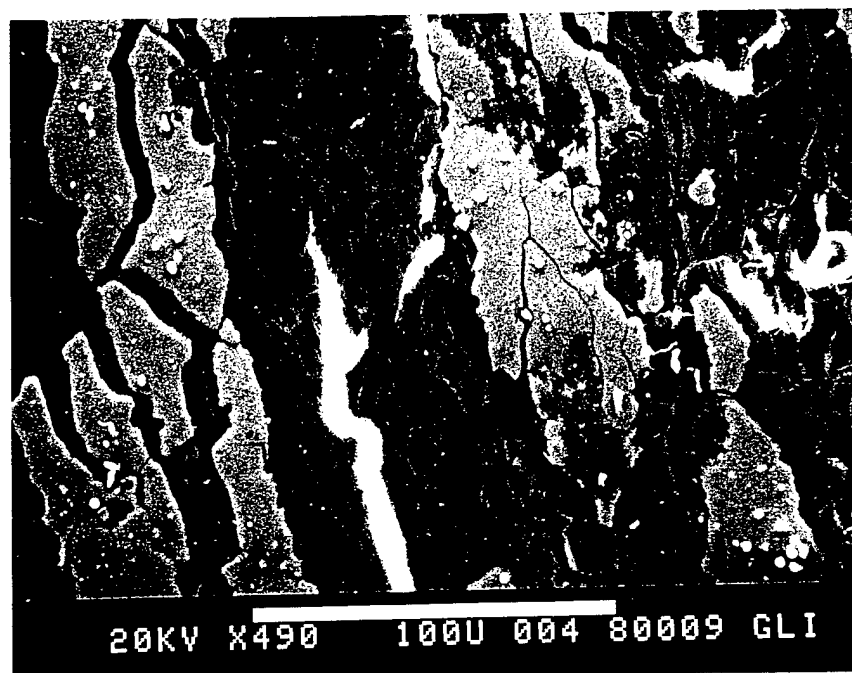
Figure 5.5.   Scanning Electron Micrographs Of Exfoliated Grains.

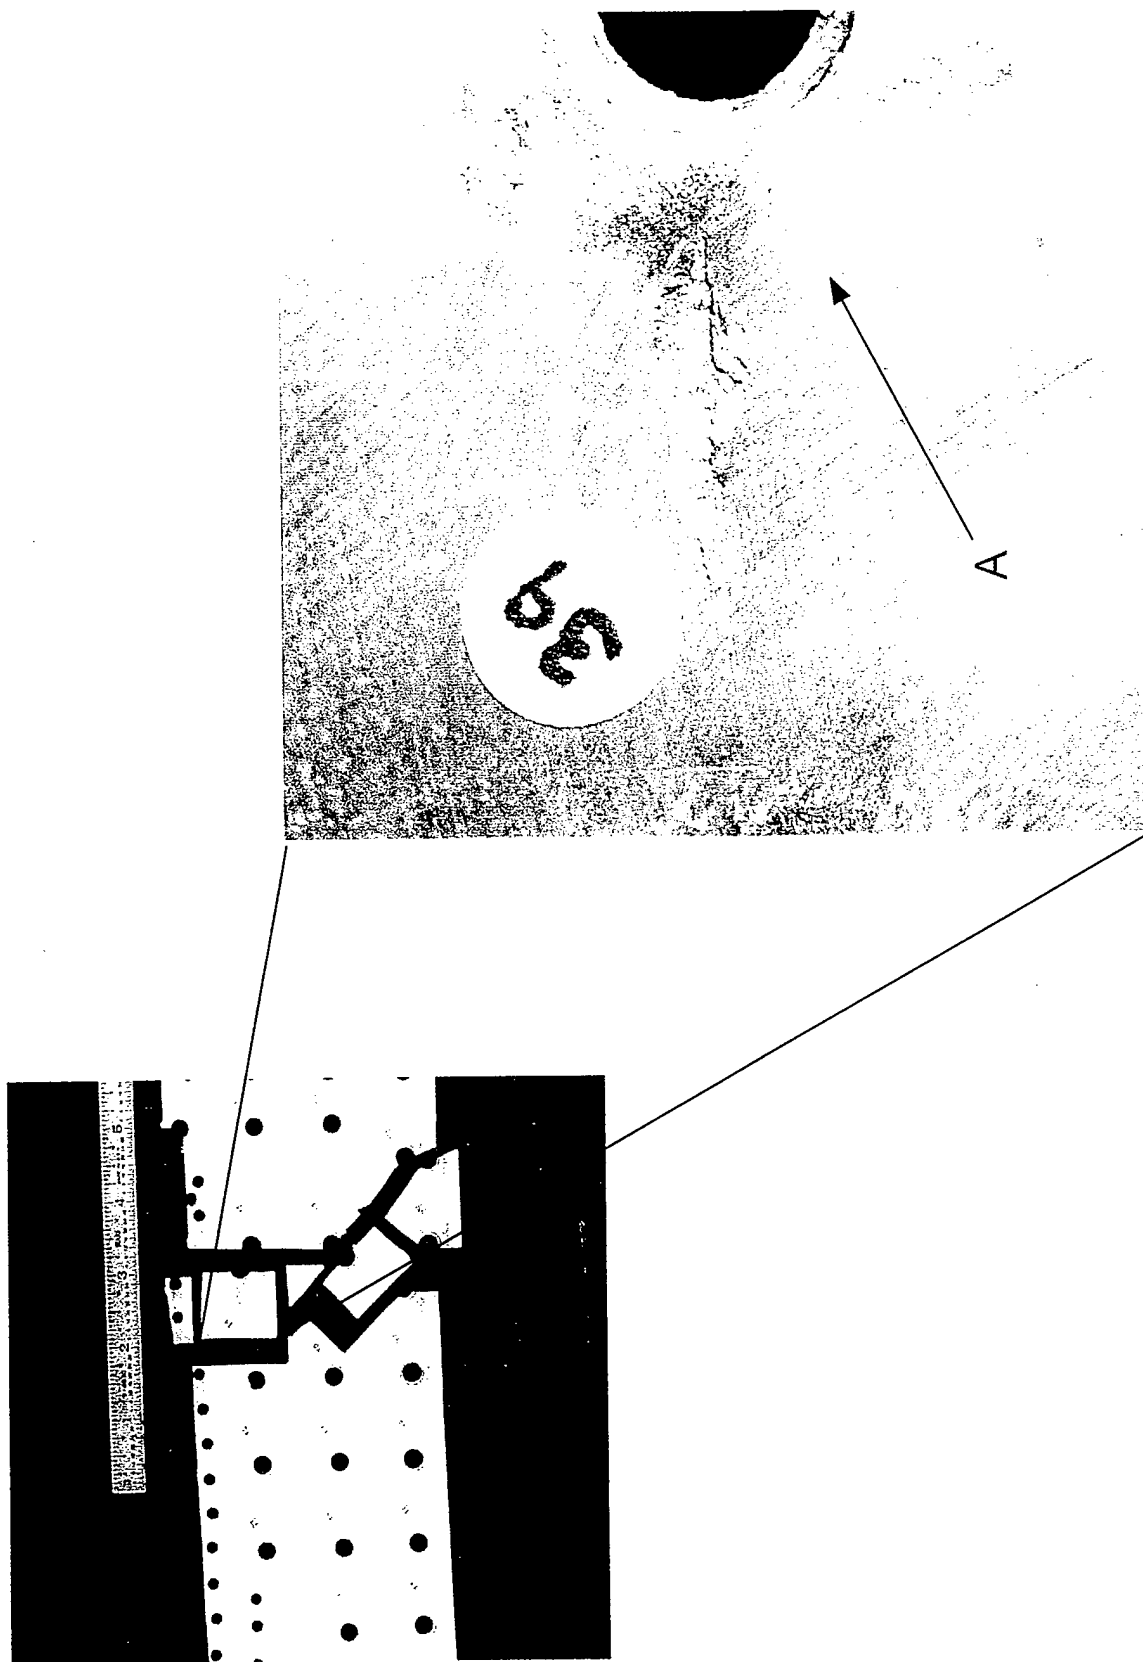
Figure 5.7   Detail Photograph of Area Adjacent to Fastener Hole 39.

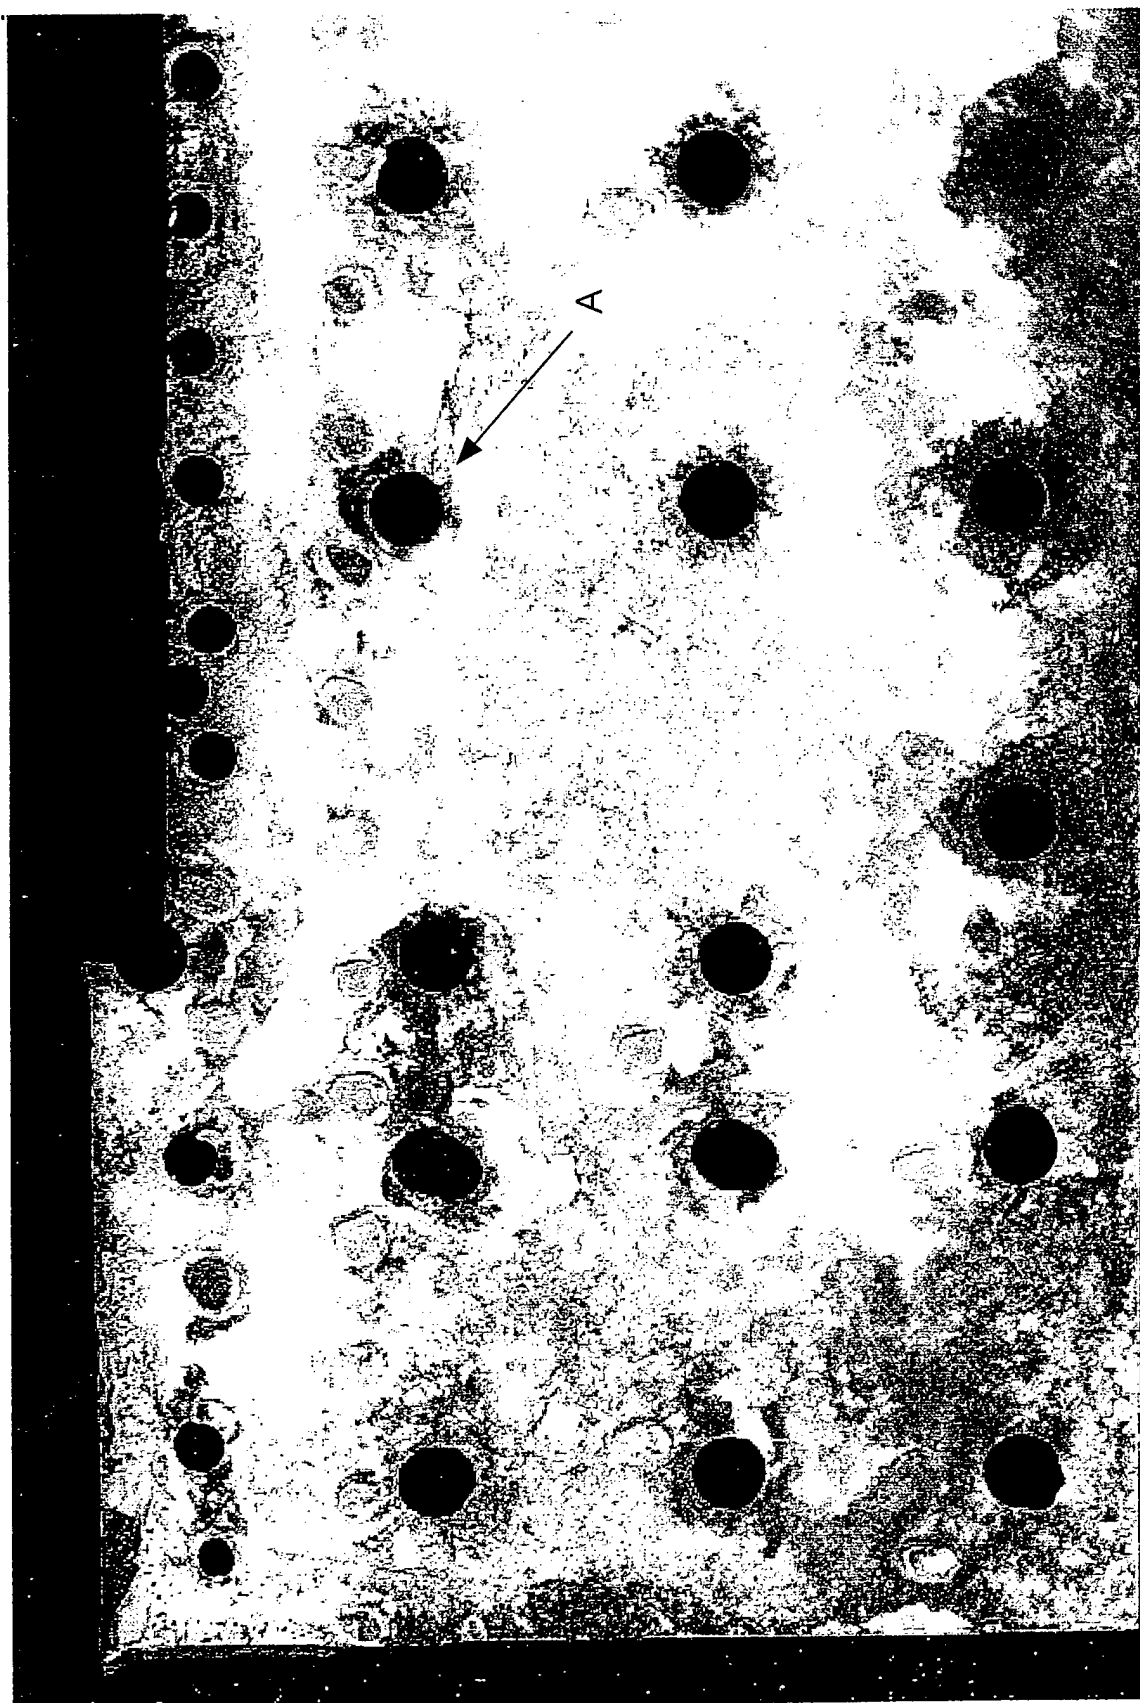
Figure 5.8   Faying Surface of the Lap Joint, Showing Area A Indicated in Figure 5.7.

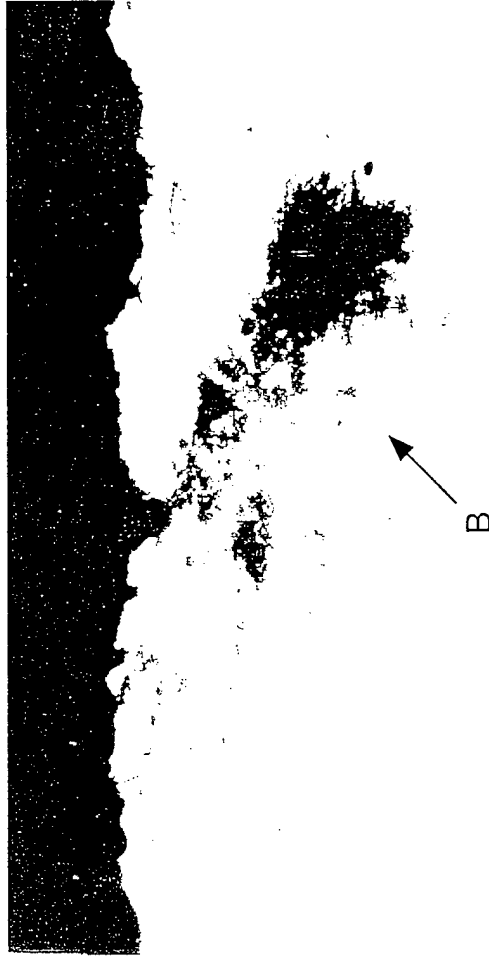
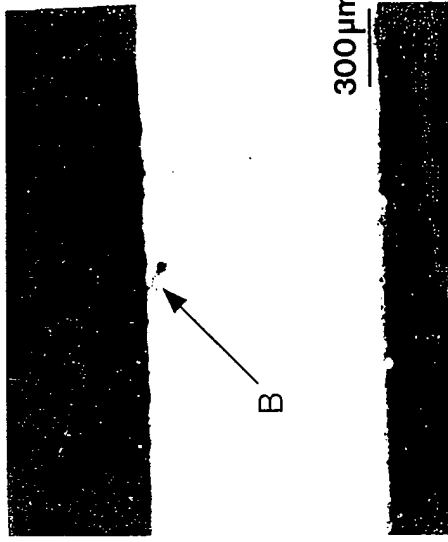
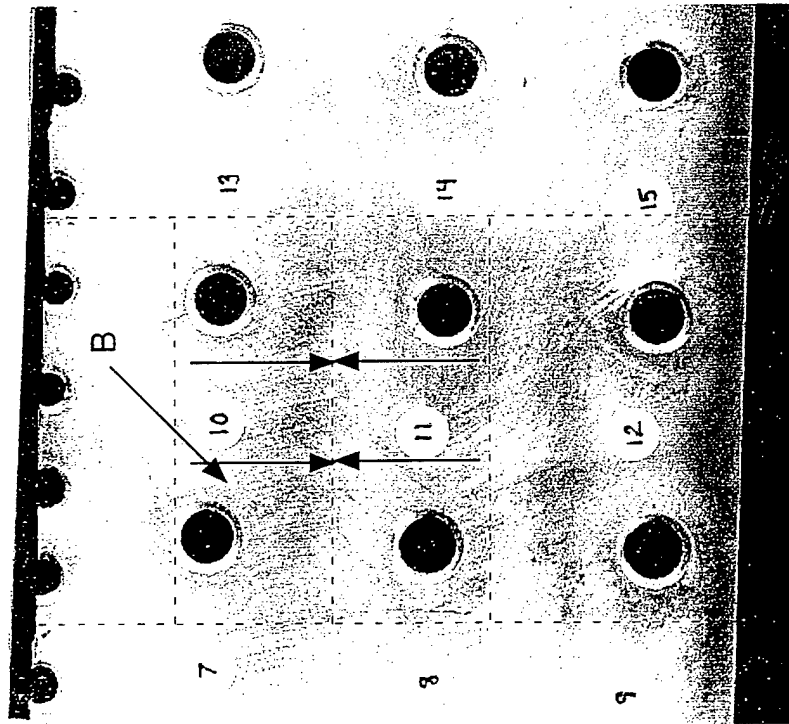
Figure 5.11   Composite Figure Showing Outside Surface of Lap Joint, which Indicates Area B where a Longitudinal Cross Section Was Made. A B a Pit and Intergranular Corrosion can be Seen.

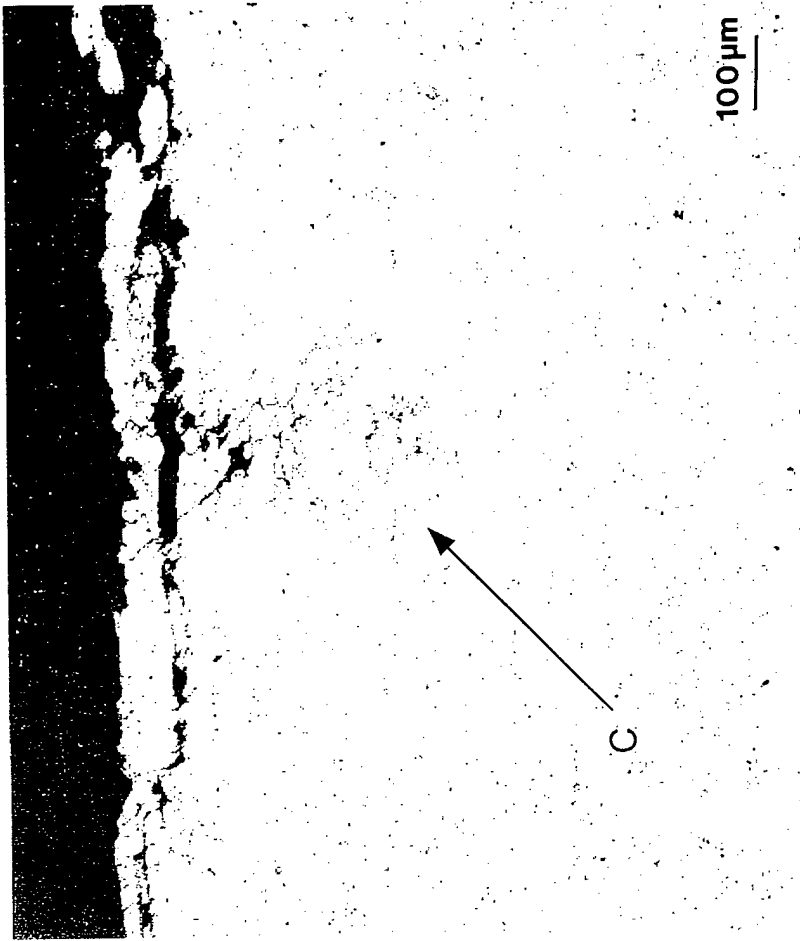
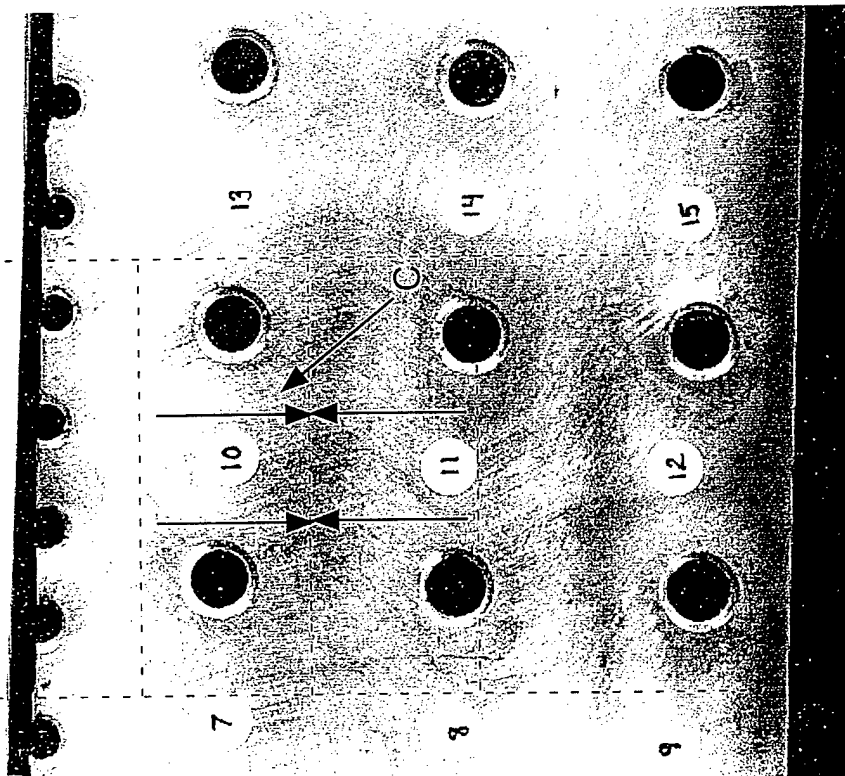
Figure 5.12 Composite Figure Showing Outside Surface of Lap Joint, which Indicates Area C where a Longitudinal Cross Section was Made. Exfoliation Corrosion and Deep Intergranular Corrosion can be Seen.

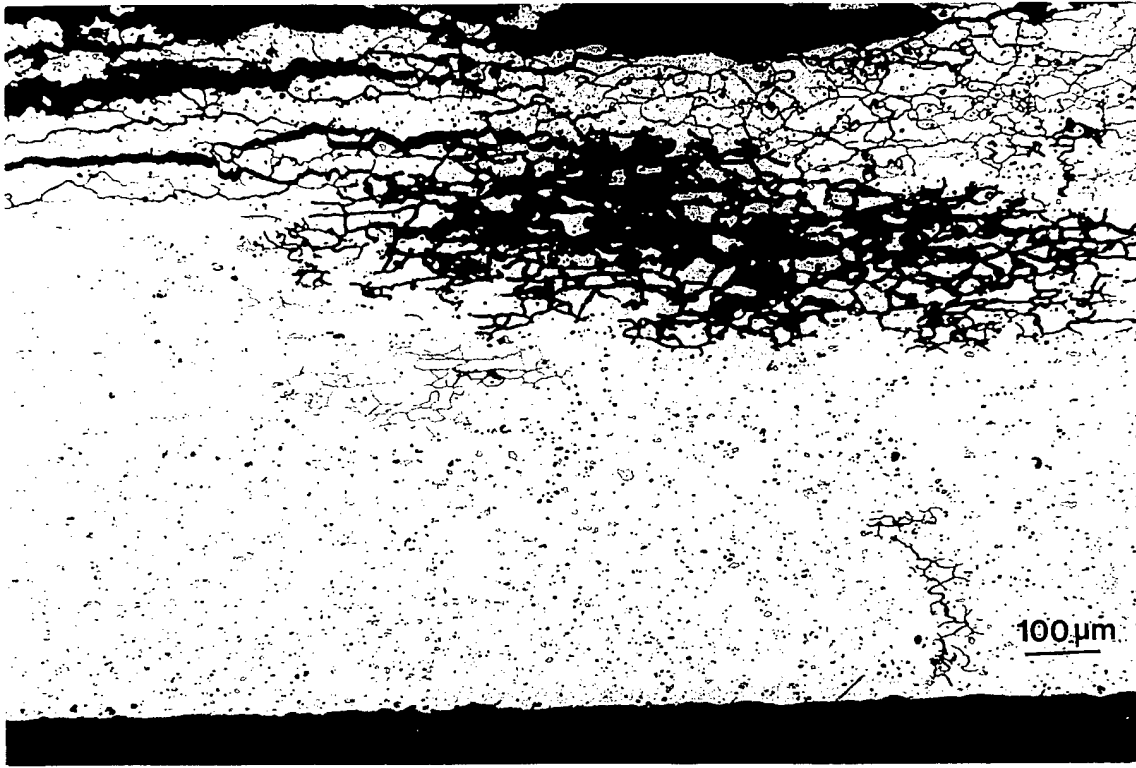
Further examination of several metallographic cross sections through the lap joint section demonstrated the presence of localized regions of intergranular corrosion in the aluminum alloy skin under the exfoliated regions. A series of optical micrographs in Figures 5.8 to 5.13 show intergranular attack to occur along grain boundaries and subgrain boundaries. This intergranular attack is very tight, which suggests that the voluminous aluminum hydroxide corrosion byproducts had not yet formed. Perpendicular cross sections such as shown in Figure 5.10 suggests that these regions of intergranular attack occur in the form of approximate hemispheres, and can propagate deep into the skin. In some case, it was found that the intergranular attack had occurred along a single path, which is characteristic of intergranular stress-corrosion cracking. Finally, there is evidence that that the voluminous aluminum hydroxides will eventually form along the grain boundaries, which will lead to exfoliation corrosion, see Figure 5.13.

Figure 5.13. Optical Micrograph Of Metallographic Cross Section Through Lap Joint Section Showing Increased Attack Of The Grain Boundaries.
